### 7.2.5 Bed-Joint Sliding

### 7.2.6 Bed-Joint Sliding at Wall Base

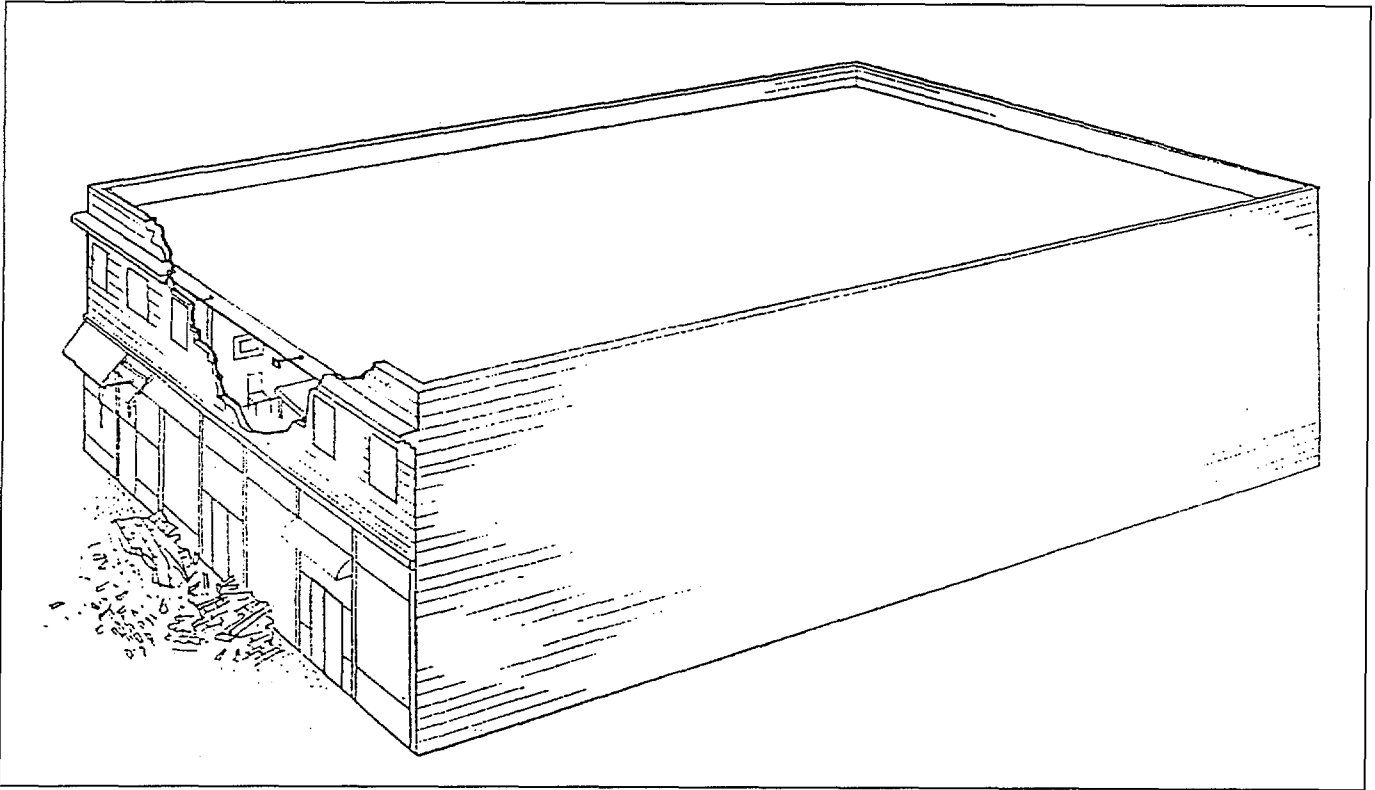
Figure 7-5 Diagram of Wall-Diaaphragm Tension Tie Failure (from Rutherford and Chekene, 1990)

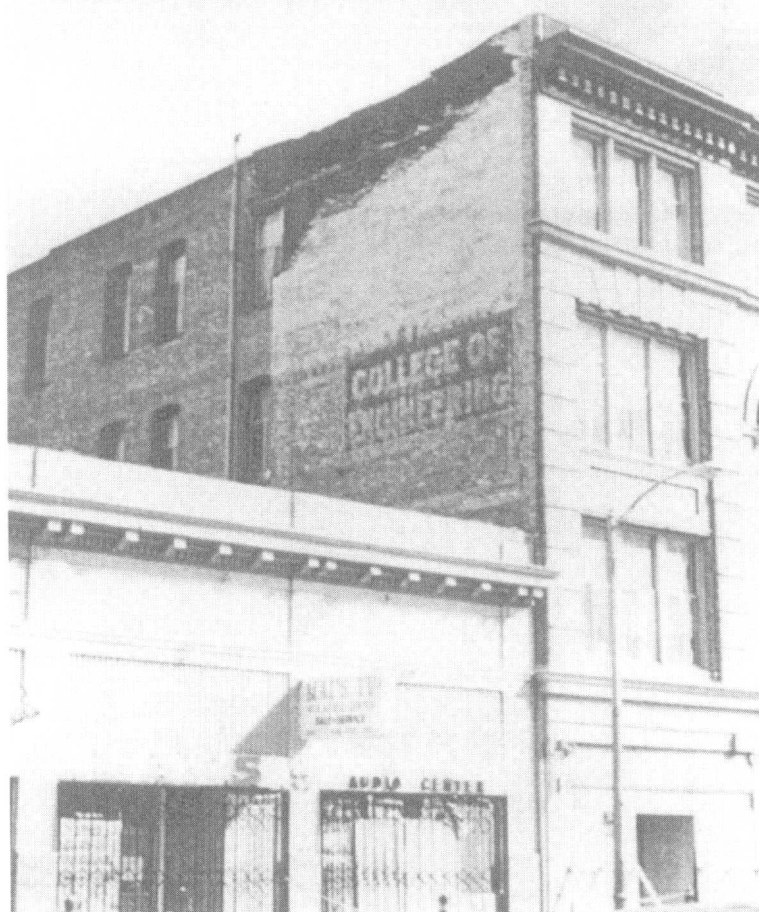
**Figure 7-6** Photo of Wall-Diaphragm Tension Tie Failure (from Rutherford and Chekene, 1990)
